# FINAL REPORT

Automated Aerosol-Sealing of Building Envelopes

ESTCP Project EW-201511

JANUARY 2018

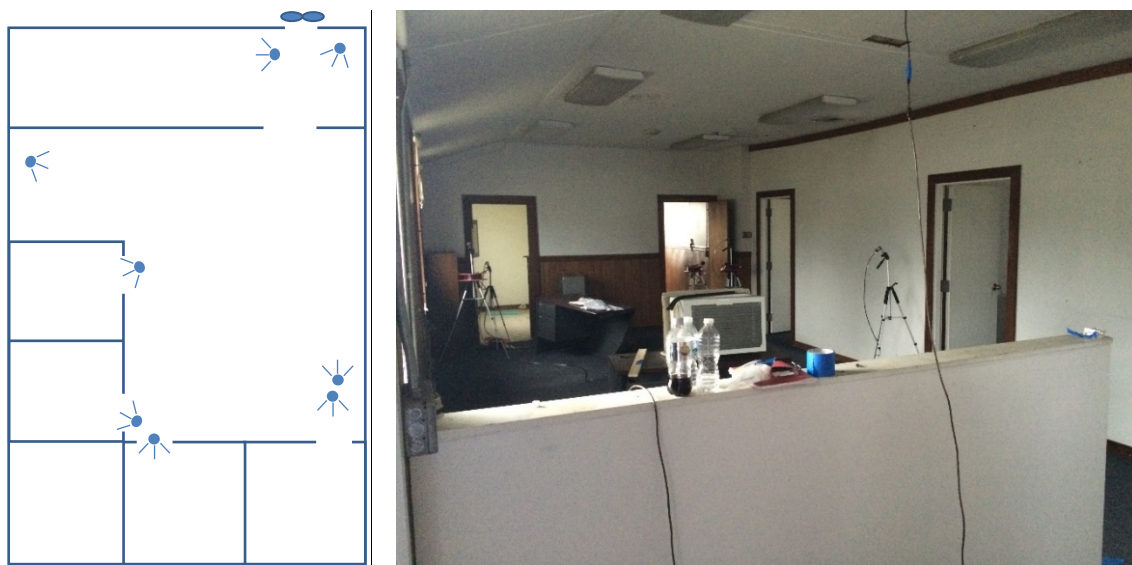
**Figure 21. Nozzle Arrangement during Sealing in A5436 (left) and Photo of Nozzle Setup (right)**

The three building sealed at Fort Bragg Army Base were completed between June 27-29, 2016. The weather during the demonstrations was considerably warm and humid, and in the case of the first demonstration, building A5436, there was periods of heavy rain (Figure 20). A total of eight nozzles were used during sealing of A5436 and Figure 21 shows the nozzle arrangement.
